SINKING SIDEWALK RESTORATION

A year after a sidewalk installation at Brigham Young University in Provo, Utah, a critical area settled 5 ½ inches. Puddles of water from rain and irrigation interrupted foot traffic.

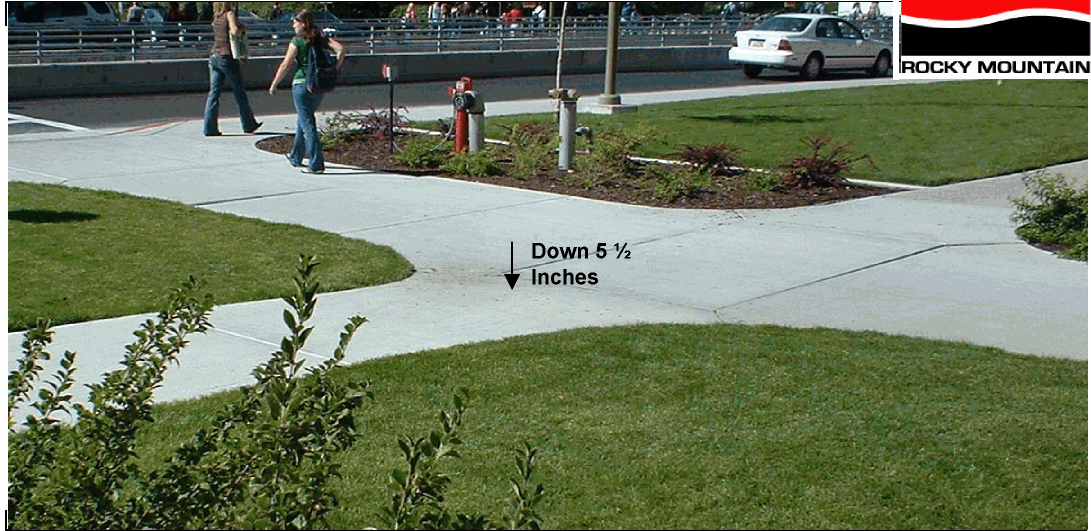
The **Uretek®** crew from **CST*** string lines across the settled area as a guide to the total lift. Then, **Uretek®** expanding polyurethane material is injected into each slab that needs to be lifted.

Surface instruments are used to detect slab surface movement to 1/1000th of an inch. Operator skill is needed to achieve the correct lift and alignment at each slab joint.

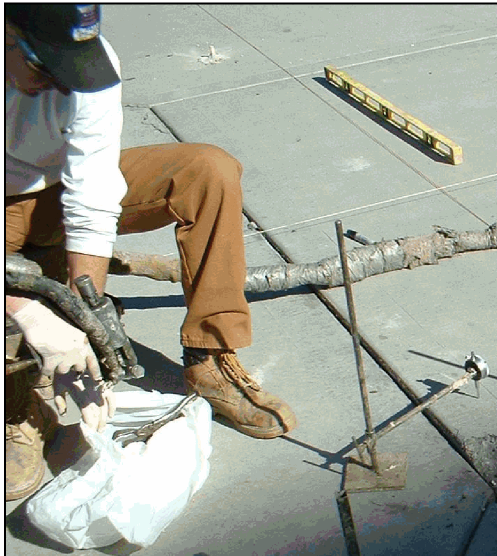
Slabs during lift process.

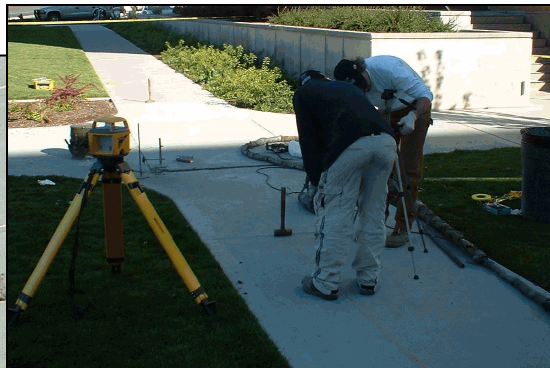
The final result is a five-inch lift, with all joints aligned, and with the proper slope required to allow water drainage as per engineering specifications.

After the lift, **Uretek®** material is injected under the slabs to fill voids and provide stabilization.

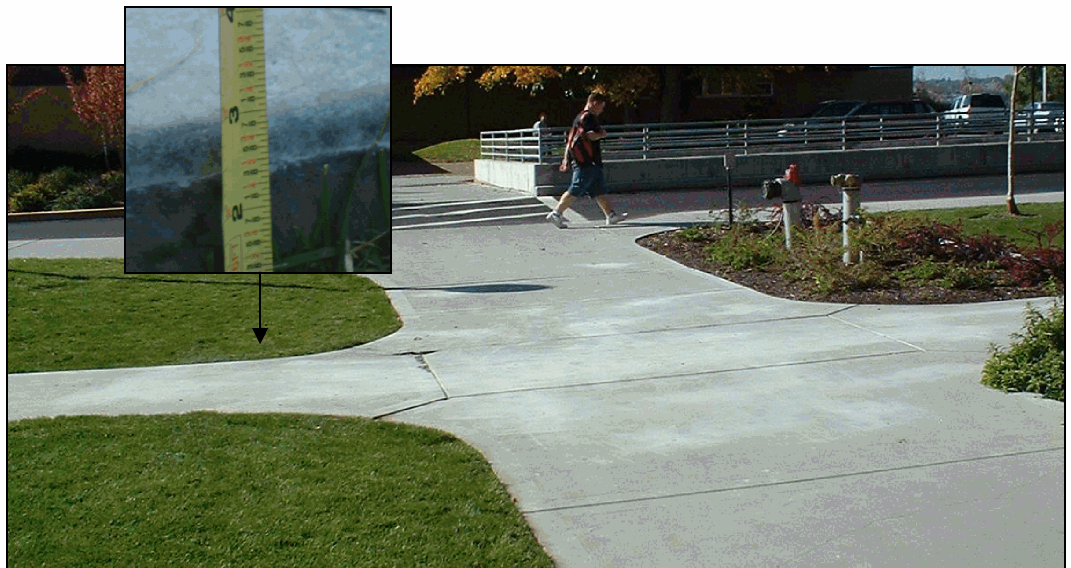
Prior to lift, the adjacent lawn area aligned with the sidewalk. After partial lift (inset) the sidewalk was up 3 inches. The contractor planned to add fill under the lawn area following completion.
